A Study on the Effect of Vibration and Nail Penetration on Lithium ion Battery and Its Material Characterization

P K Ajeet Babu, U S Karle, M R Saraf
Technology Group

The Automotive Research Association of India, Pune, India

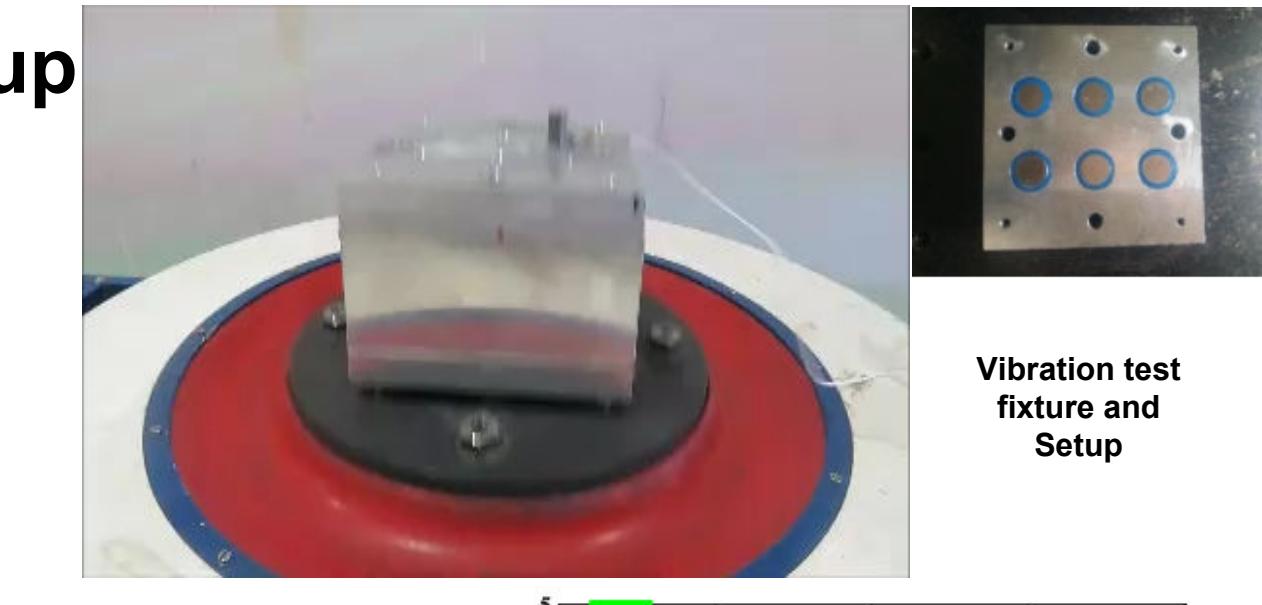
Vibration test fixture and Setup

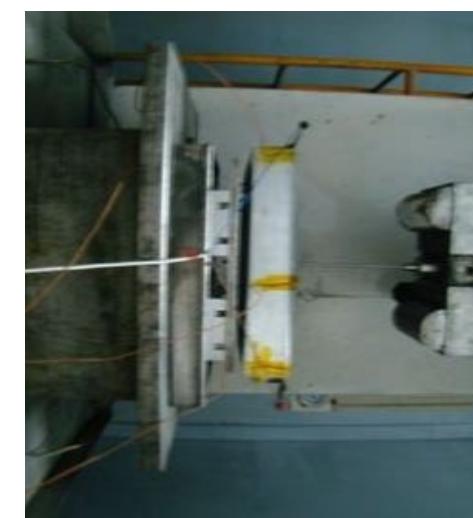
Nail Penetration Test Setup

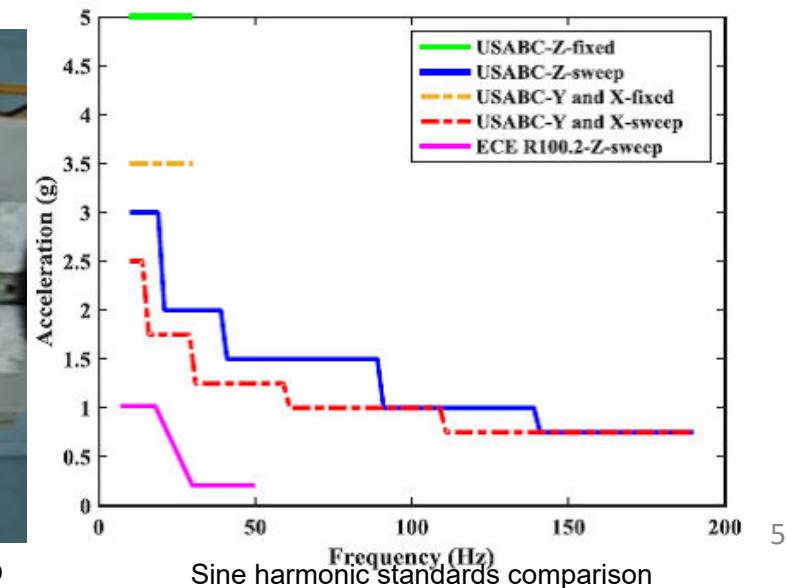
Sine harmonic standards comparison

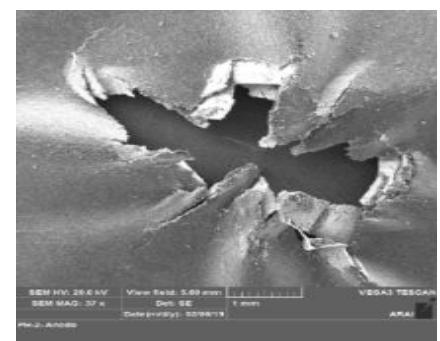
Centre Region

Cathode

- 50% SoC : - At top cracks were observed in the morphology but at the centre the grains were completely destroyed
- 100% SoC : - The average grain size increased from 0.56 μm to 1 μm .

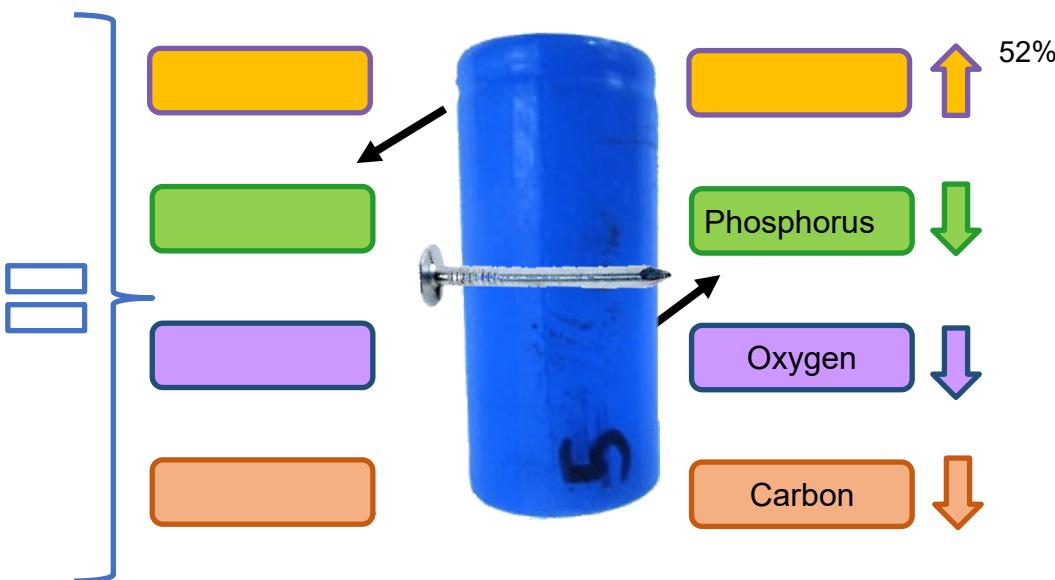
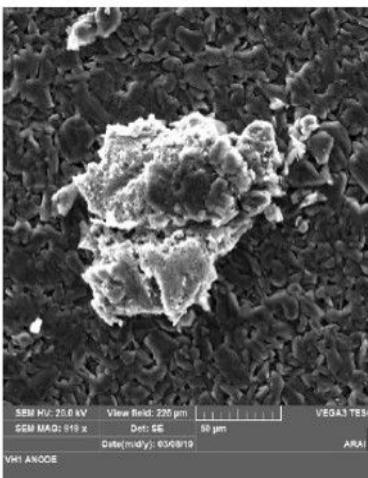
50% SoC

- With respect to anode, the elements such as C, O and P is found similar before and after penetration test at both the locations
- At Cathode, There is significant difference in the elements before and after penetration test at centre

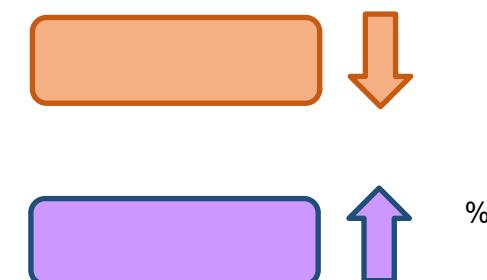
100% SoC

- The elemental distribution of cathode was similar to new cell
- In Anode Traces of iron element is observed in the destroyed anode.

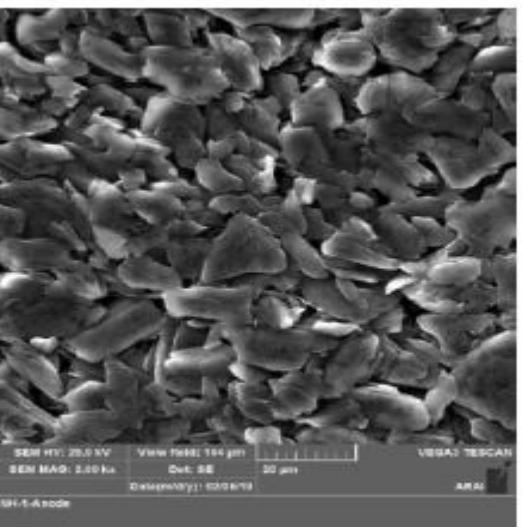
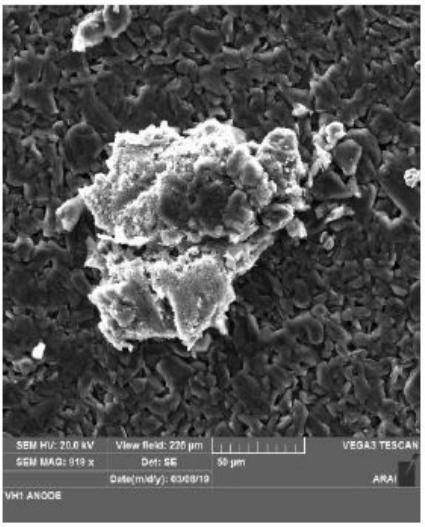
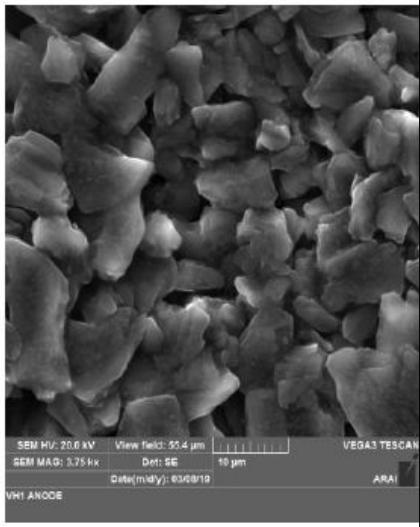
- The anode was found intact, but throughout the surface presence of tower like structure is observed, Which is due to transfer of material from the cathode.
- It is observed that the anode has additional deposition of oxygen, phosphorus and iron which has come from the cathode, as compared to the new cell anode.

Anode after vibration test

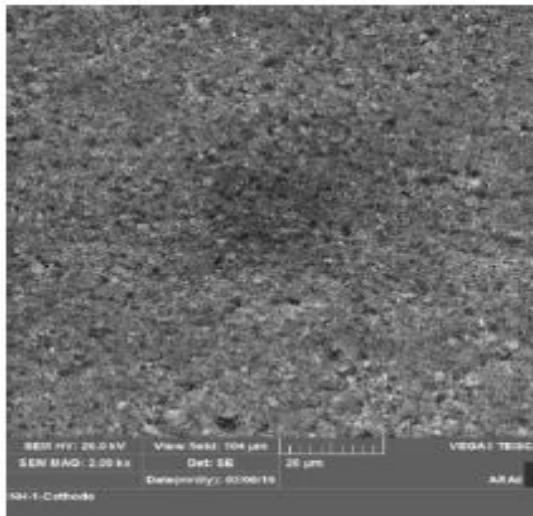
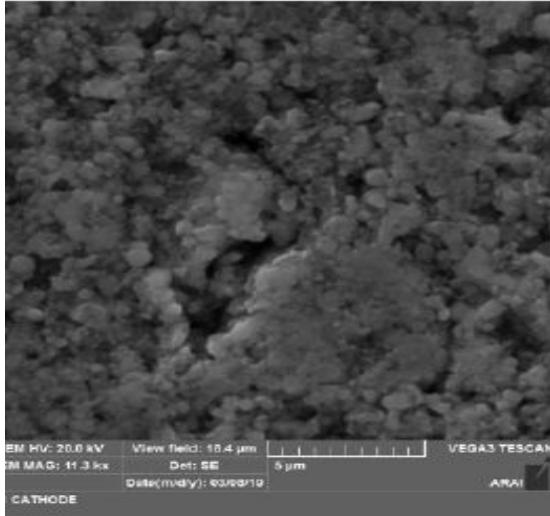
Cathode after vibration test

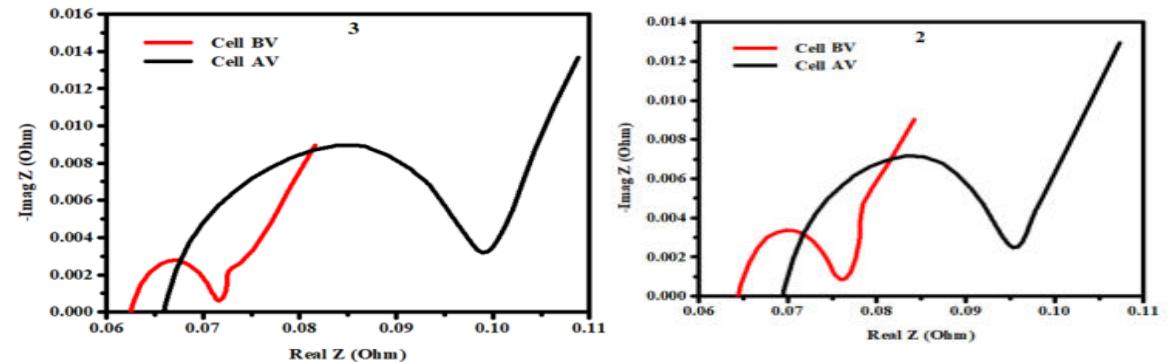
- The resistance of the new cell at 50% SoC is found to 30-35 mΩ
- Voltage drops from 0.3 to 0.4 V
- Test showed increase in the internal resistance by 5-25%

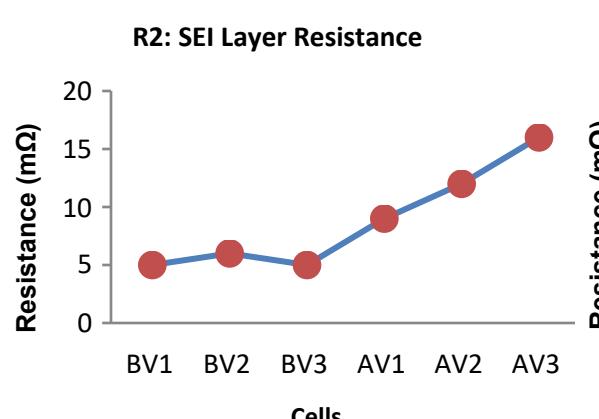
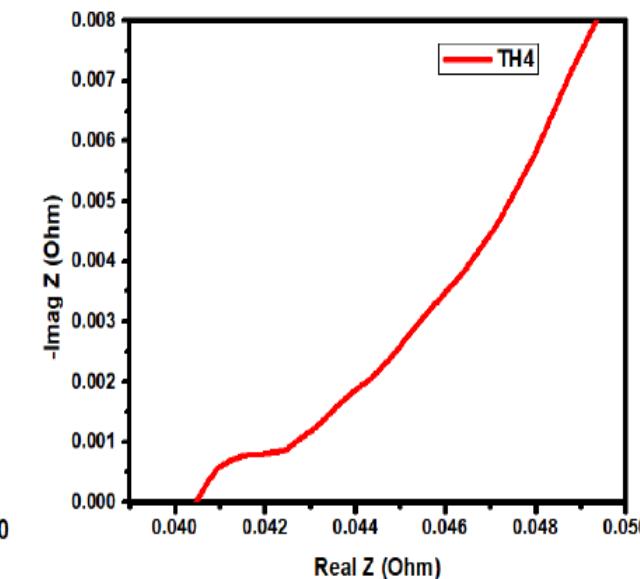
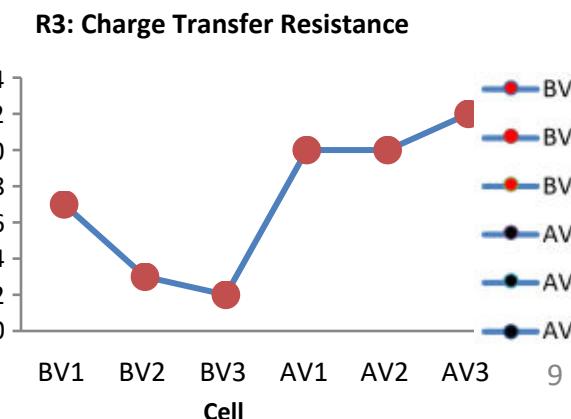
Nyquist Plot for 32700 Cell tested before and after Vibration testing

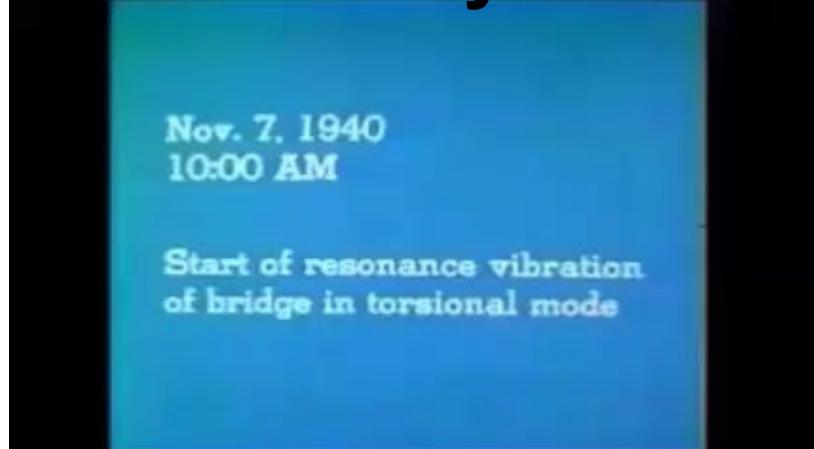
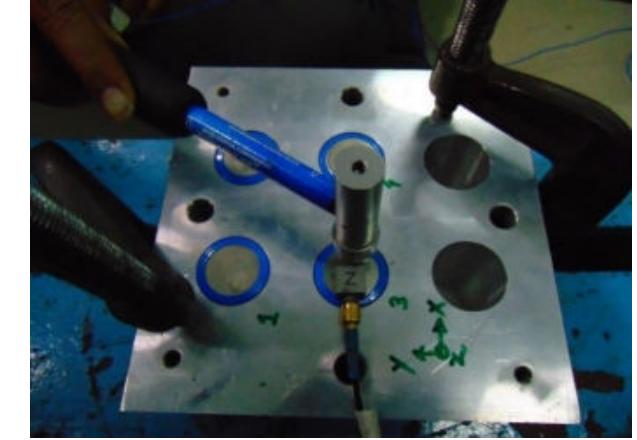
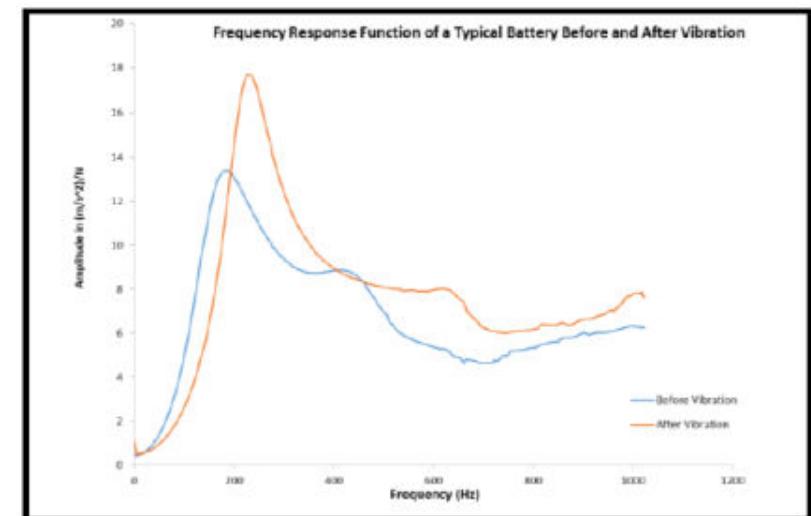
Modal Analysis After Vibration Test

Cells	Max Amplitude (m/s ²)/N		Max Amplitude's Freq, Hz		Dynamic Stiffness at Max Amplitude Freq (N/mm)	
	Before Test	After Test	Before Test	After Test	Before Test	After Test
1	15.3	17.0	156	216	63	109
2	15.1	15.3	177	270	82	188
3	13.4	17.7	183	231	99	118
AVERAGE	14.6	16.7	172	239	81	138
